# Understanding Spur Gear Life

## TRSM0913

May 2011

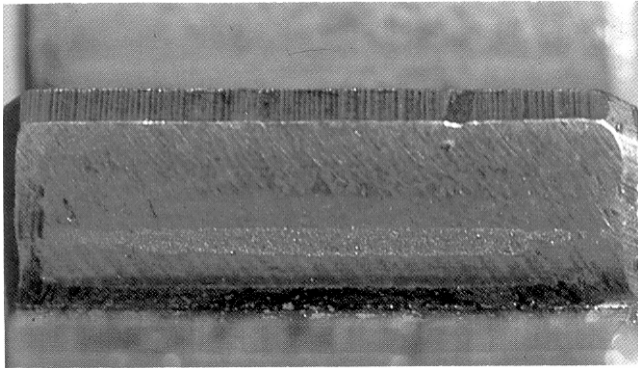
### Frosting

As noted before, during mesh specific areas of the tooth surface are in contact during each stage. However, variations in the tooth form between mating teeth may produce a slight change in the contact pattern. This will result in light wear as the mating gears seek to adjust to a common pitch line. Since this wear is in a sliding zone starting near the root of the gear, it causes a form of micro-pitting. Magnification is required to see the pits. To the eye, it looks like a band of off-white discoloration called “frosting”. There is a lack of sheen at this stage.

A gear should not be replaced simply because of frosting. But if it also shows other signs of distress, such as tip loading, misalignment, severe surface irregularities, etc., then further investigation is needed. These signs will be discussed later.

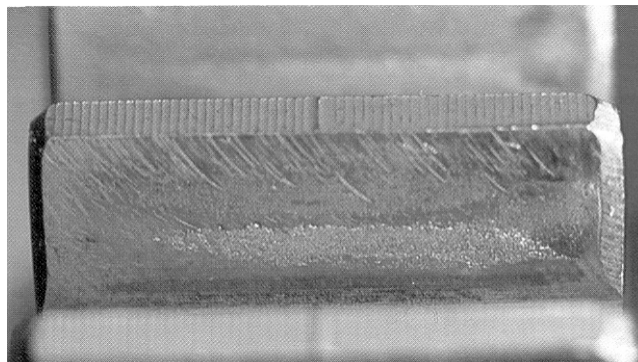
### Offset Frosting

As previously stated, there are acceptable tolerances in tooth lead. Mating gear teeth can successfully operate with lead variation in opposite directions. However, a small amount of load shifting may occur. Slight wear may take place until the load is again evenly distributed across the entire tooth width. This may also result in frosting in the dedendum portion and sometimes in the addendum portion of the tooth, offset from the tooth center. Again, under normal conditions, healing will take place and gear life will not be lost.

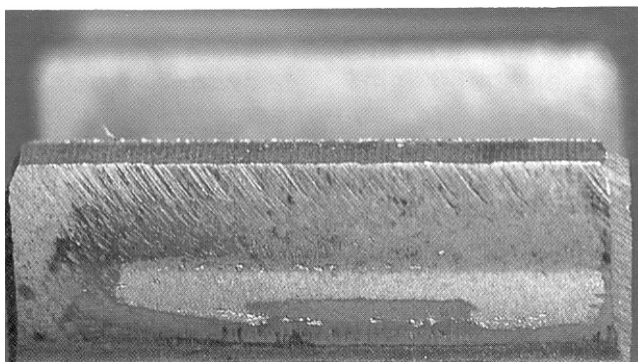
### Healing

As seen in the photo, the pitch line is generally well defined. The balance of the frosting will take the shape of the contact area, no matter what it might be. Under normal conditions, the contact zone wears away; the rate of wear decreases until the point is reached where it polishes itself out and the frosting is totally replaced by a very shiny area. No further wear takes place. This is called “healing” and absolutely no gear life is lost at this stage.

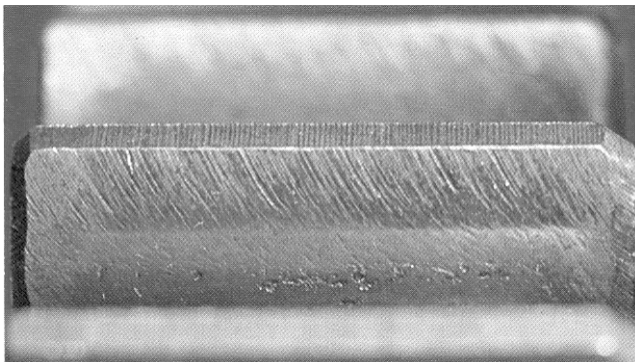
## Initial Pitting

"Initial pitting" is the mildest stage of pitting. It consists of definite pits from pin hole size, just larger than frosting and barely noticeable to .030 inches (.762mm) in diameter.

Generally, initial pitting continues until the tooth is able to carry the load without further distress. Do not replace a gear because of initial pitting, as it will not cause noise and in many cases will heal over.

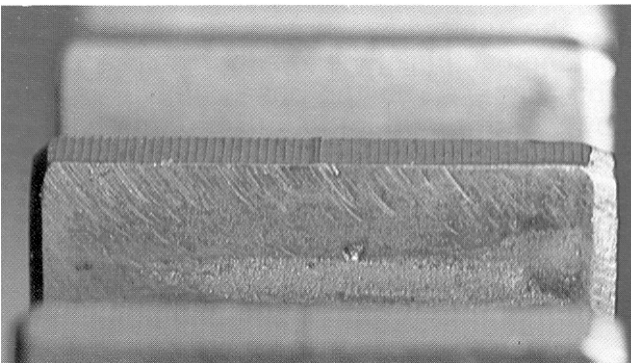
## Combinations

You can see under normal operation, a gear can have a "combination" of tooth distress, frosting and/or initial pitting. Again, all are likely to heal over.

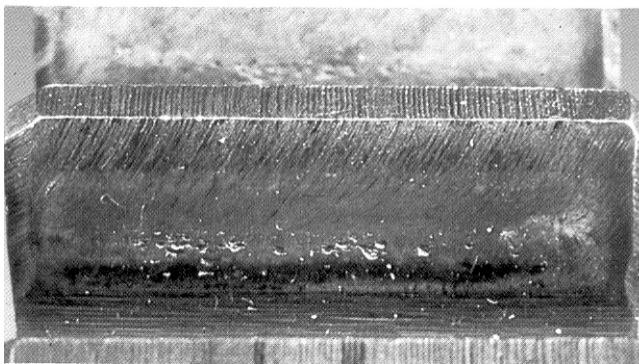
### Moderate Pitting

This gear shows pit craters approximately .060 inches (1.524mm) in diameter and .005 to .010 inches (.127mm to .254mm) deep, about twice the size of craters in initial pitting. The pits are widely distributed across the face of the tooth. This gear has lived about 50% of life. The teeth have not been significantly weakened at this stage and there is no danger of breakage. As in the case with gears that show frosting and initial pitting, this type of "moderate pitting" will not cause noise. This gear can give many more miles of useful service.

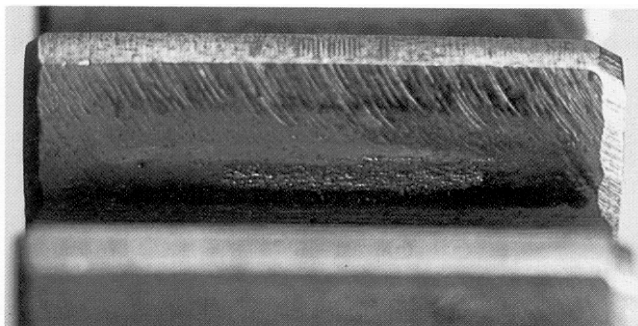
This gear also has pitting on approximately 50% of the tooth surface, but unlike the previous gear shown, this gear should be replaced. The pitting is concentrated and at the pitch line, which changes the involute form. Although the teeth have not been significantly weakened, noise can be generated because the involute form no longer falls within the tolerance band discussed earlier.

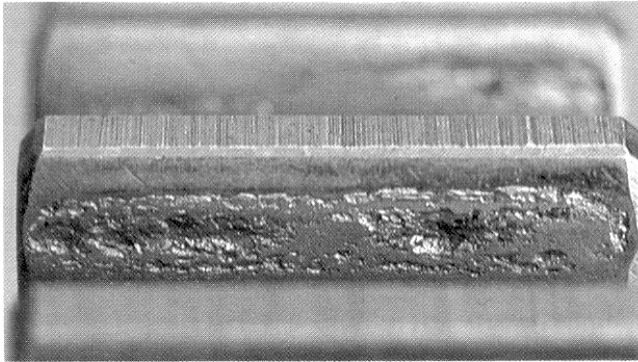
## Destructive Pitting

The pitting on this gear is well advanced into a “destructive” stage. The pit craters are considerably larger and deeper than those in moderate pitting. Gears in this stage of pitting should be replaced, or noise and fatigue fractures may occur.

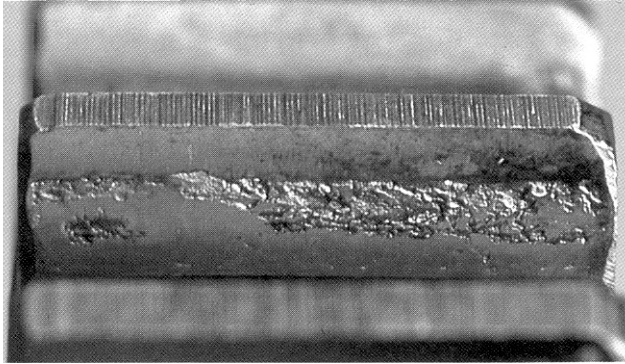
### Spalling

“Spalling” is similar in appearance to destructive pitting except the craters are larger in diameter and shallower in depth. Spalling occurs over a short period of time when a gear is subject to an extreme overload condition.

Major forms of distress are primarily caused by a severe case of the factors given for minor and progressive forms of distress. These forms can occur at any time in the gear's life. Whenever they occur, all gears in the set must be replaced.

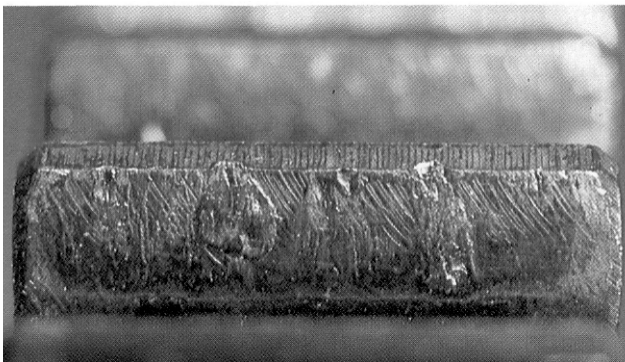
### Scoring

“Scoring” is caused by an insufficient oil film between mating gear teeth, resulting in very high surface temperatures. This results in an alternate welding tearing of metal which is rapidly torn from the tooth surface. Insufficient oil film can be caused by: Low oil level, excessive transmission operating angles, high operating temperatures, poor quality, incorrect viscosity oil, and by mixing types of oil.

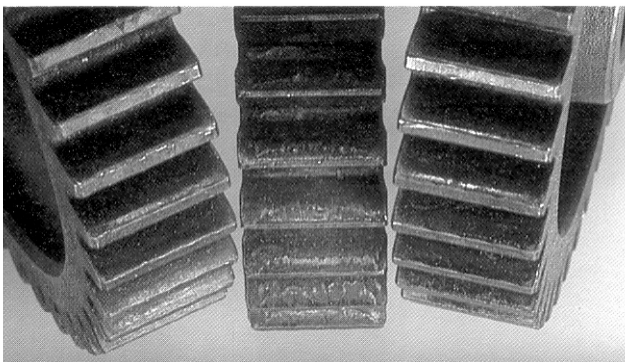
### Burned Head Set

When inspecting a transmission with a “burned head set”, it is not unusual to find the main drive gear badly scored, with only slight visible damage to the mating countershaft drive gears. This occurs because the teeth of the main drive gear make contact almost three times as often as the teeth of the mating countershaft drive gears. When replacing a burned main drive gear, also replace the countershaft drive gears, even if there is no visible damage.

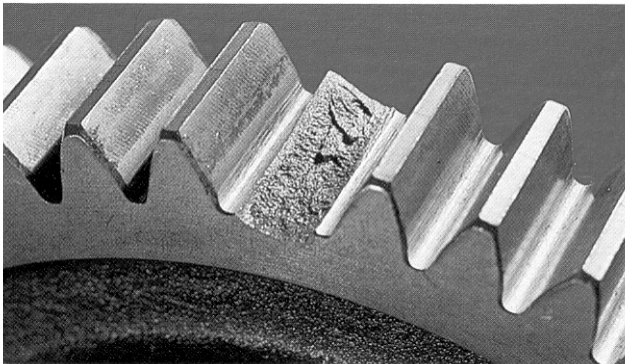
### Impact Fractures

“Impact fractures” are caused by a severe shock load or a foreign object passing through the gear mesh. They are identified by a “bump” on the compression side of the fractured area. The more cycles the gear has run after the fracture, the smaller the bump will be. In addition to the gear which has a tooth fracture, the other two gears of the set should also be replaced, even though they may look undamaged. All gearing in the transmission should be inspected for possible damage caused by the broken tooth running through the transmission.

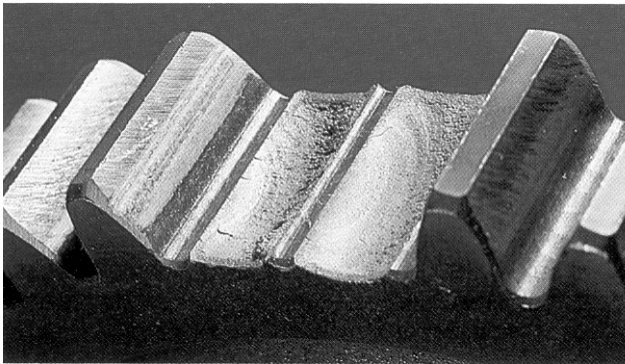
### Fatigue Fractures

“Fatigue fractures” are caused by extremely high stresses on a gear tooth over a period of time.

- Shock loads causing a small crack in the tooth.
- Tooth damage from objects going through the gear mesh.
- An overload condition.
- Forging imperfections, excessive machining marks, or improper heat treatment.
- Severe pitting or surface fatigue.

Fatigue fractures are identified by “beach” marks on the fractured area. These marks are made as the tooth progressively cracks under a load heavy enough to enlarge the crack but not great enough to break the entire tooth off at one time.

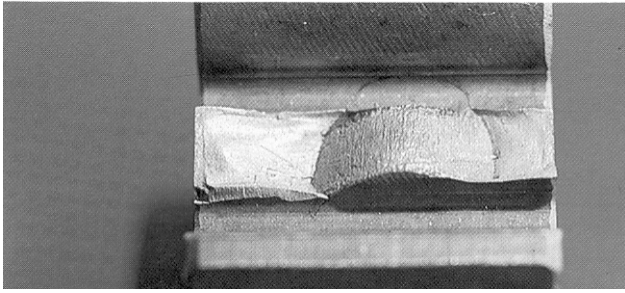
## **Stingers or Gas Pockets**

Gears made from base metal which contain “stringers” or “gas pockets” have weak points at those areas. These fractures can be identified by the difference in fracture shape and metal texture in the break surface. Again, as with other fractures, inspect all gearing in the transmission for possible damage.
