# Eaton® Clutches CLTS1271

September 2011

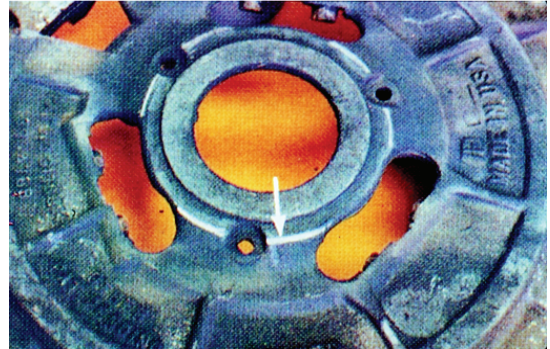
The arrows in Figures 1 and 2 show the areas of contact between the release yoke bridge and the clutch cover. Overstroking of the yoke, in an attempt to obtain the required 1/2" - 1" clutch brake squeeze, is a typical cause of this failure.

**Note:** The clutch cover can be reused if the above items are corrected, a new yoke is installed, and there are no broken or cracked parts on the cover. The above failure is typically preceded by a noise complaint and/or vibrating clutch pedal at the point where the clutch pedal is fully depressed. Depending upon the amount of wear (at the bearing cap and/or yoke fingers/wear pads), it may be possible to adjust the linkage to eliminate the noise complaint.

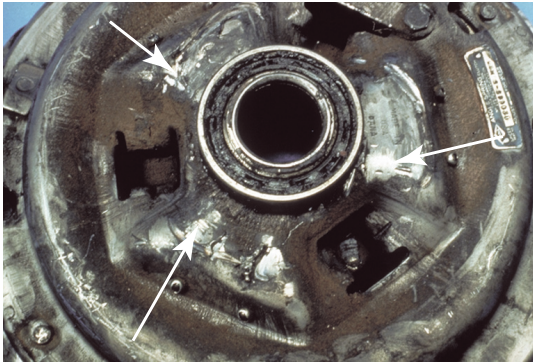
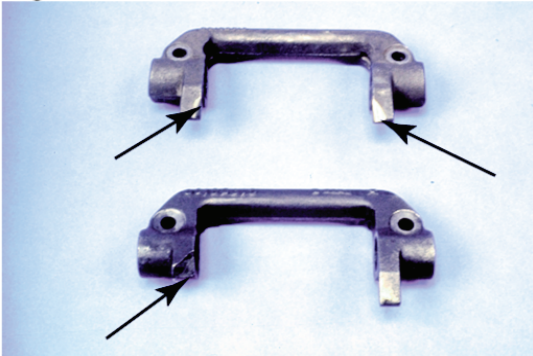
Figures 4 - 5 show the damage that results when the release yoke contacts the clutch cover. More specifically, the fingers have become pinched between the clutch cover and release bearing, resulting in one or more of the following:

- A broken /cracked release bearing housing (not shown)
- Damage to the clutch cover (see arrows, Figure 4)
- Wear to the backside of the yoke fingers (see arrows in Figure 5, top yoke)
- Broken yoke finger(s) (see arrow in Figure 5 bottom yoke)

- Linkage system broke, allowing the loose yoke to contact cover
- Linkage system was improperly reinstalled (example: forgetting to reinstall the cotter key, allowing the clevis pin to come out)
- Adjusting the clutch with the linkage instead of internally using the adjusting ring
- Rotating the ring the wrong direction (counterclockwise instead of clockwise) when adjusting for clutch wear

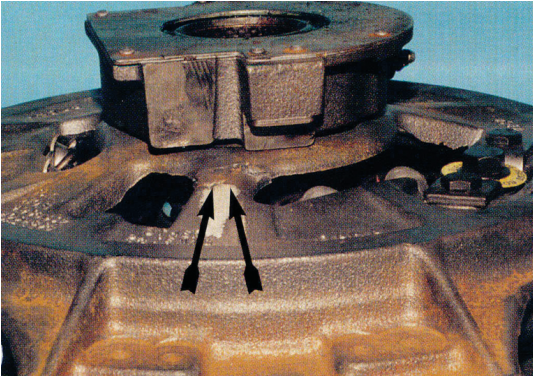
Fig 6

Referring to the arrow in Figure 6, this brand new clutch (Easy-Pedal 1402 S.D.) was damaged during transmission installation. More specifically, the release yoke "fingers" were elevated to the "straight out position" and were allowed to jam into the clutch cover. Subsequent damage might be a broken finger(s)(Figure 5) or bent release yoke / cross shafts. As a result, it is important that these parts be inspected for damage (and replaced if damaged) before installing a new clutch.

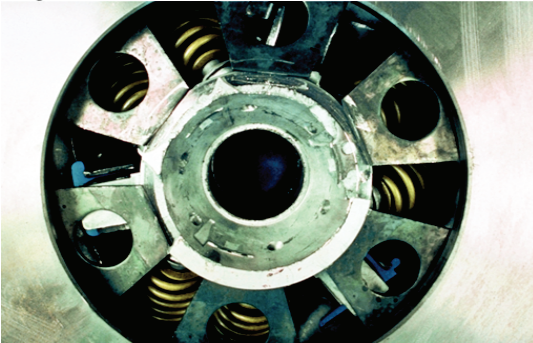
Fig 7

Figure 7 shows what can happen when the levers break through the retainer's nose. The primary cause of this failure is allowing the transmission to hang unsupported in the driven disc during transmission installation.

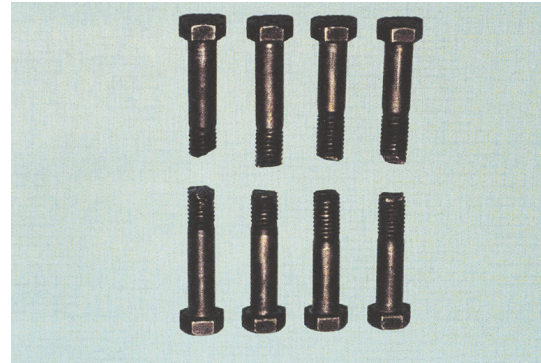
Fig 8

The broken mounting bolts, show in Figure 8, are the direct result of insufficient torquing of these (8) bolts to the flywheel. More specifically, these bolts were loose enough to allow the clutch cover to hammer back and forth against each bolt until they broke. Also, the (8) mounting bolt holes in the clutch cover were “egg-shaped” as a result of the constant hammering.

Another potential cause of the above failure would be the over-torquing of the mounting bolts. Doing so can cause the bolts to fracture and eventually separate from the flywheel. Combining this scenario with low grade mounting bolts will increase the chances of failure.

**Note:** Refer to the Eaton Installation Instructions (packaged with each clutch) to determine the proper mounting bolt torque, minimum grade of bolt, etc., for the specific Eaton Fuller Clutch model you are installing.

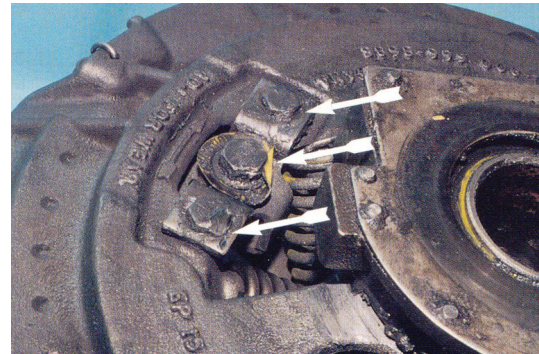
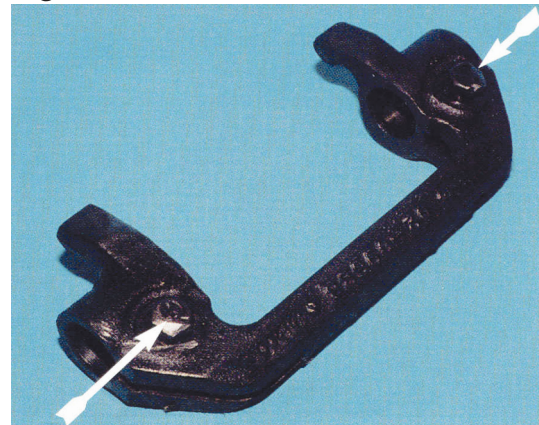
Additional damage occurred to both the clutch cover and the release yoke as a result of their interference with each other (refer to the arrows in Figures 9 and 10). It is worth noting that this service clutch had accumulated 50,000+ miles before it failed.

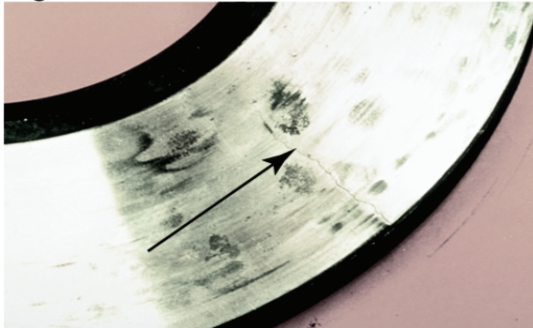
Fig 13

Figures 13 - 16 depict damaged clutch plates which resulted from an abnormal amount of clutch slippage/heat. Some causes of this abnormal slippage/excess heat can be one or more of the following:

Figure 13 is an example of a cracked pressure plate. The heat flow was so great that the metal could not dissipate it quickly enough.

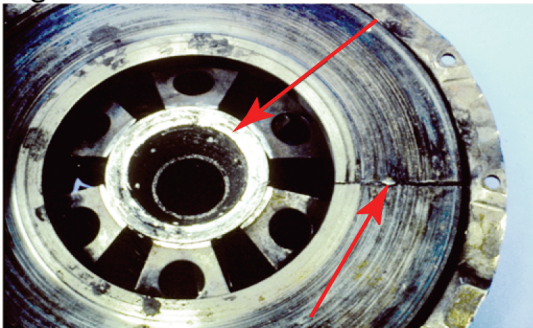
Fig 25

Figure 25 shows the damage done to the nose of the retainer assembly (see arrow) due to contact with the disc rivets. Figure 57 shows the resulting damage done to the rear disc. Adjusting the clutch externally (with the linkage) instead of internally (rotation of adjusting ring) will cause the retainer sleeve/release bearing assembly to move too far forward as the clutch wears, leading to this failure.

An additional result from the above failure is that while the clutch is engaged, it can begin to slip due to the unloading condition created by the disc and retainer interference. This, in turn, will create excessive heat and can cause the pressure plate to break (see Figure 25, black arrow on pressure plate) and/or the ceramic buttons to separate from the disc (see Figure 58). The above failure may also be preceded by a noise complaint.

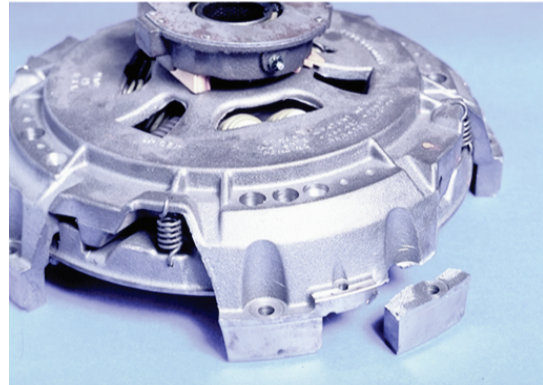
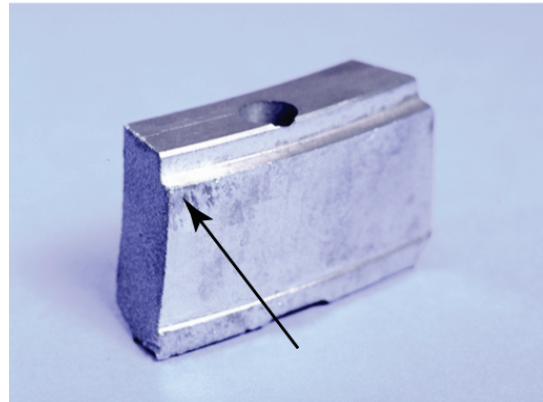
The photo in Figure 27 is a close-up of the broken leg shown in Figure 26. The arrow in this close-up shows where the leg contacted the concrete floor after the clutch was dropped.

**Note:** Eaton Clutch does not provide warranty coverage for this type of failure.

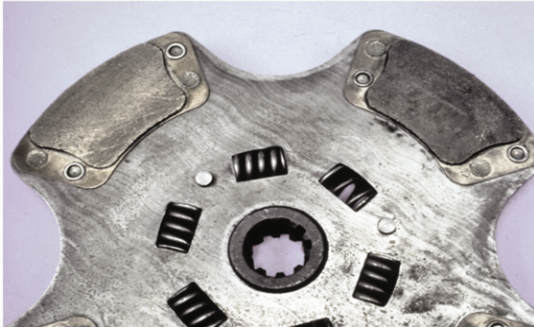
Fig 43

Figure 43 shows a disc with grease on its buttons, flywheel side. When this disc was removed from the truck, all four buttons had a heavy layer of grease on them. The left button has been cleaned to show the contrast with the grease-covered button on the right. Failing to remove the grease (rust preventative) from the flywheel (new or resurfaced) can cause this problem.

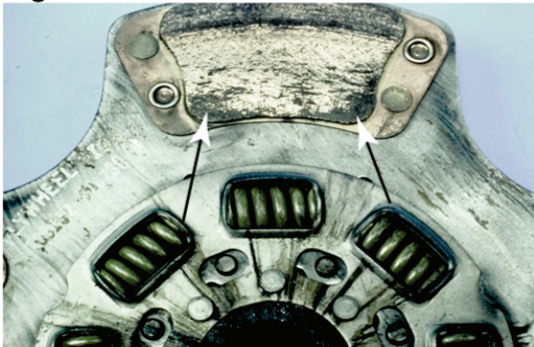
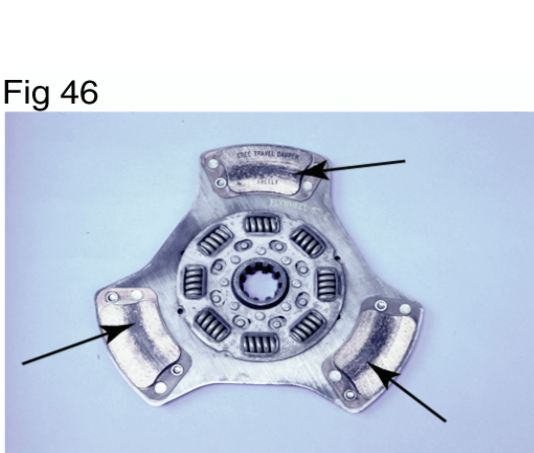
Greasing the splined areas of either the input shaft or disc hub(s) is not recommended because the grease can be spun onto the facing material of the driven disc(s) (refer to both arrows in Figure 44). The circled area in Figure 45 reveals the numerous paths which the grease took as it moved toward the buttons (facing material) of this ceramic driven disc. The photographs in Figures 44-45 are of the same driven disc.

**Note:** Eaton does not recommend the reinstallation of driven discs which have become contaminated with grease or oil.

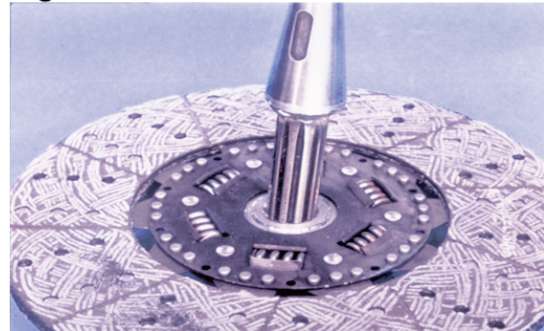
Fig 47

Shown in Figure 47 is a brand new driven disc which was warped during transmission installation (as indicated by the dummy input shaft which is not perpendicular to the disc's hub). More specifically, the transmission was allowed to hang unsupported in the driven disc hub. A driven disc which has become bent due to improper installation techniques should not be reused because of the potential for a "poor release" complaint.

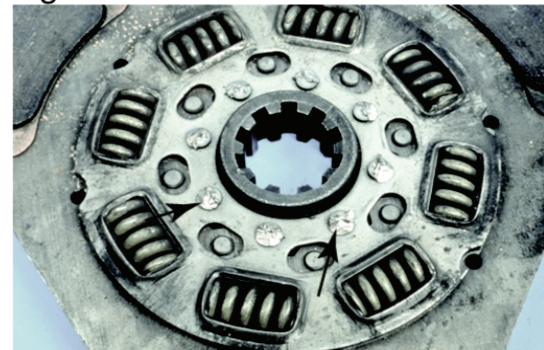
Fig 48

- The rivets of the disc (Figure 48) have been contacting the flywheel's mounting bolts. Some potential causes of this particular interference are as follows:
  - a. Loose flywheel mounting bolt(s) due to inadequate torquing.
  - b. Forgetting to tighten one or more of the mounting bolts when reinstalling the flywheel.
  - c. Installing an extra washer under the flywheel mounting bolt.
  - d. A flywheel which has been resurfaced too many times.
- The damper springs (see arrows, Figure 49 and 50) have been contacting the flywheel mounting bolts because the front driven disc was installed backwards. The driven disc (in Figure 49) had been wearing for a period of time before the interference occurred (as indicated by the full wear pattern on the ceramic buttons) while the one in Figure 50 was run for a very short period.

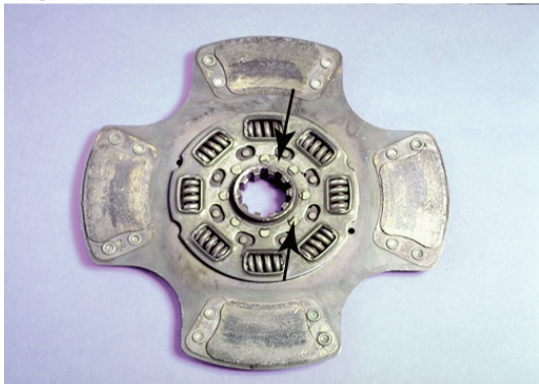
Fig 51

- A disintegrating pilot bearing which is interfering with both the hub and rivets of the driven disc (Figure 51).

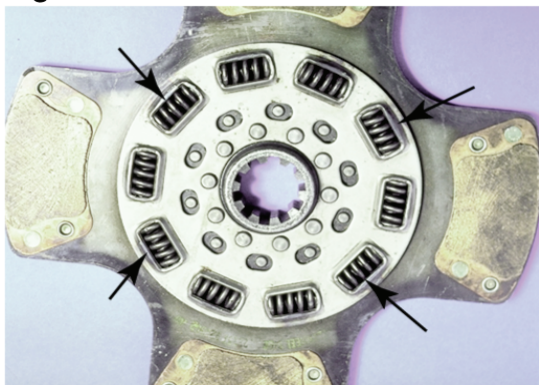
Fig 52

- Installation of the wrong clutch. Figure 52 (see arrows) shows the points of interference that resulted when a 10-spring driven disc was installed where an 8-spring was previously being run. In other words, the recessed area of the flywheel (mounting bolt cavity) was too small for the 10-spring driven disc. Before you mount the new clutch, consult the Eaton Installation Instructions (packaged with each Eaton Fuller Clutch) concerning "potential damper interference". A driver complaint, resulting from the above failure, can be:
  - a. The clutch does not release
  - b. The clutch is noisy during operation

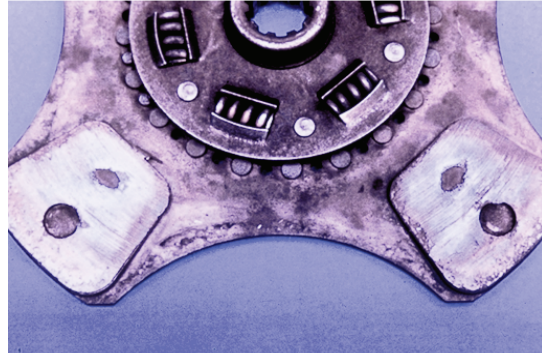
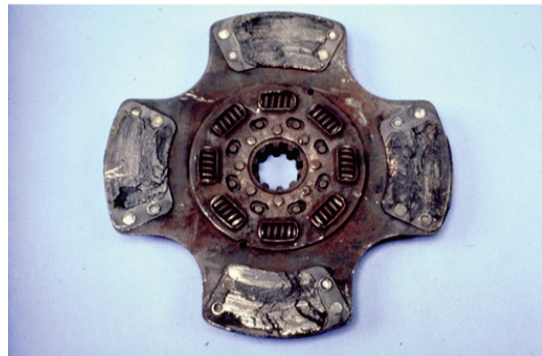
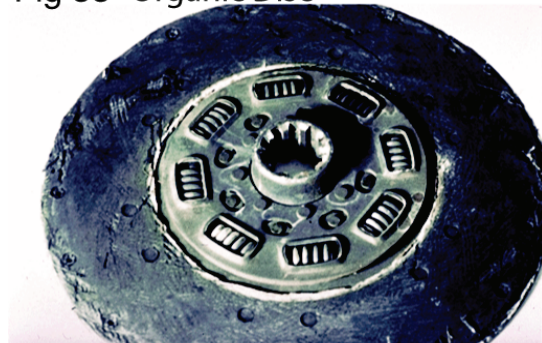
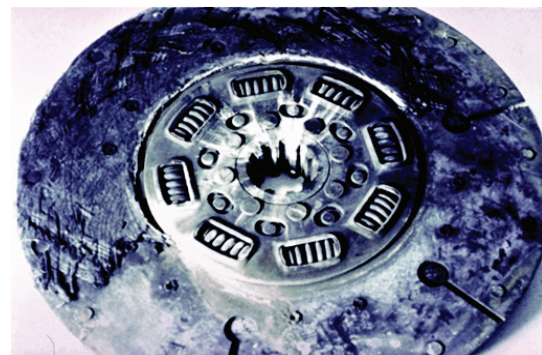
- Lack of free pedal
- Constantly riding the clutch pedal
- Utilizing a slipping clutch as a brake on an incline
- Partial unloading of a clutch due to a binding linkage system, interference, etc.
- Installation and use of improper clutch (wrong application)
- Worn driven disc facings

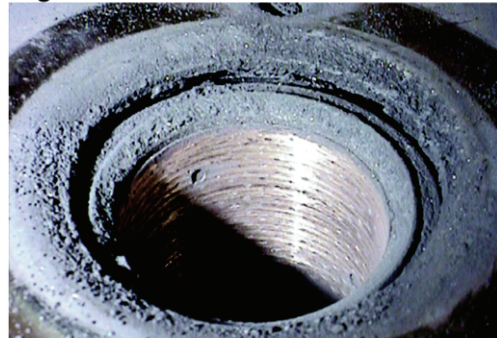
Fig 77

As shown in Figures 77 and 78, incorrect lube or not enough lube can cause a failure. External contamination will also cause wear to the bushing. The transmission input shaft may be rough and require replacement. Use approved/compatible lube. (High quality N.L.G.I #2 or #3 lithium soap grease with E.P. additives 325 degree operating temperature or Roadranger MP-2). Apply ample lube and let it flow out of the opening from the bearing housing. Apply additional lube onto the transmission shaft to ensure the bushing will have proper lube. Apply lube to the tips of the release yoke.
