# Eaton® Clutches CLTS1271

September 2011

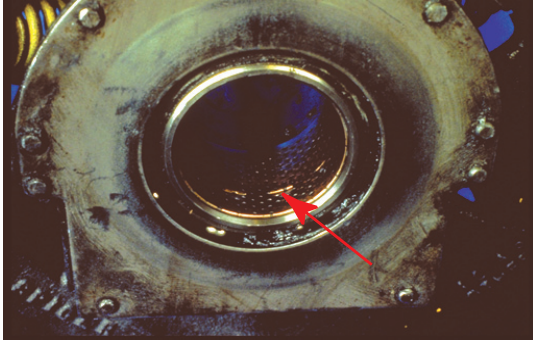
Fig 11

Failure to center the input shaft with the sleeve of the release bearing assembly, when installing the transmission, can cause this failure. If the transmission hangs up during installation, investigate the cause before proceeding as excessive force can damage the bushing (see arrow in Figure 12). Allowing the transmission to hang unsupported in the sleeve bushing can damage the bushing. The arrow in Figure 11 shows another example of sleeve bushing damage on a heavy duty clutch.

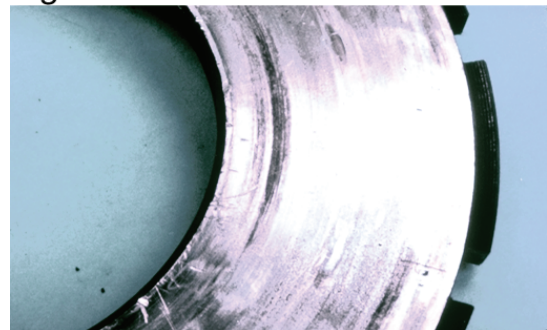
Fig 16

Finally, Figure 16 reveals an example of a burned or scorched intermediate plate in which the metal became so hot that it began to flow. The typical evidence of such a failure will be one or more of the following:

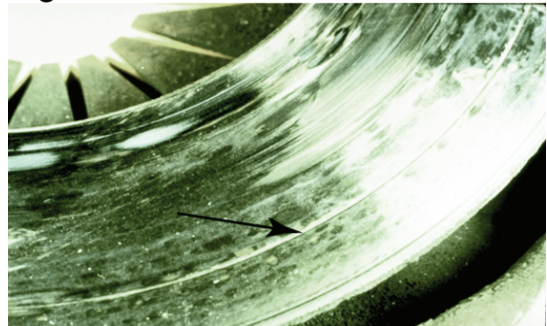
Fig 17

The groove (see arrow in Figure 17) worn into the face of this pressure plate was caused by the rivets of the driven disc facing. (For the related disc failure, see the description under Figure 70). The same damage can occur on both the intermediate plate and flywheel. A surface that is grooved can damage the new driven discs that are installed. As a result, a new clutch assembly should be installed. Refer to the OEM service manual concerning fly-wheel resurfacing.

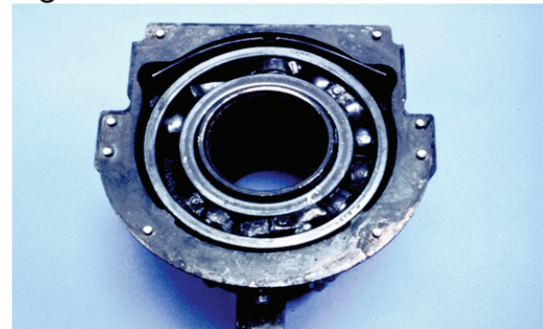
Fig 28

A failed release bearing (see Figure 28) can usually be attributed to one or more of the following situations:

- A dry release bearing due to lack of periodic lubrication (does not apply to sealed bearings).
- Failure to fully release or riding the clutch pedal will place a constant thrust load on the bearing, (see arrows in Figure 29) leading to higher temperatures and consequential loss of lubricant. Failure to maintain free play up in the cab can also cause this condition. Not only will the bearing begin to fail, constant contact in this area will cause both the release yoke fingers (Figure 79), and the wear pads (Figure 29), to wear excessively.

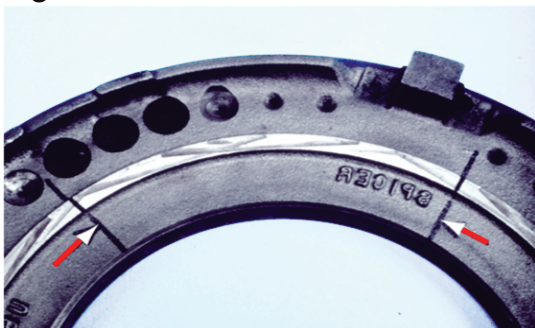
Fig 39

Figure 39 shows the back of the pressure plate. This clutch has been properly adjusted (internally, using the adjusting ring) because each of the 6 levers has more than one witness mark (or lever fulcrum point).

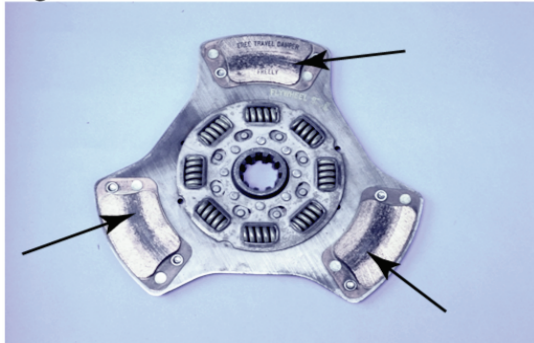
Fig 46

The exception to the above wear pattern is described in detail in Figure 46. The title of this description is: "Failure - Abnormal wear pattern at middle of disc button".

## Failure - Abnormal Wear Pattern at Middle of Disc Button

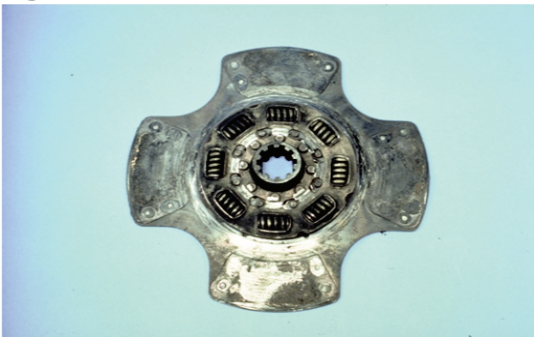
Fig 58

An additional result from the above failure is that while the clutch is engaged, it can begin to slip due to the unloading condition created by the disc and retainer interference. This, in turn, will create excessive heat and can cause the pressure plate to break (see Figure 25, black arrow on pressure plate) and/or the ceramic buttons to separate from the disc (see Figure 58). The above failure may also be preceded by a noise complaint.

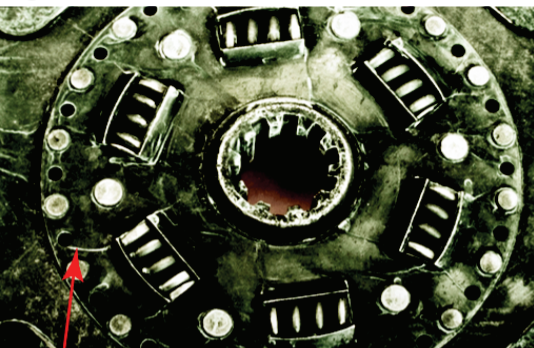
Fig 59

The cracks shown in Figures 59 and 60 (see arrows) can result from:

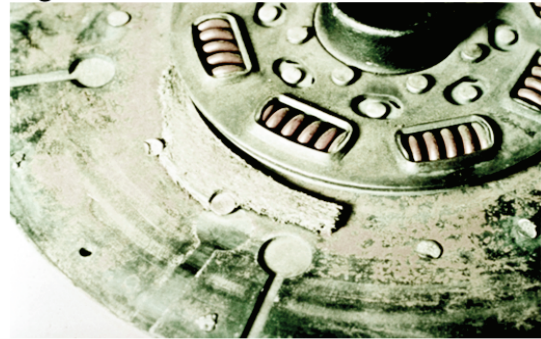
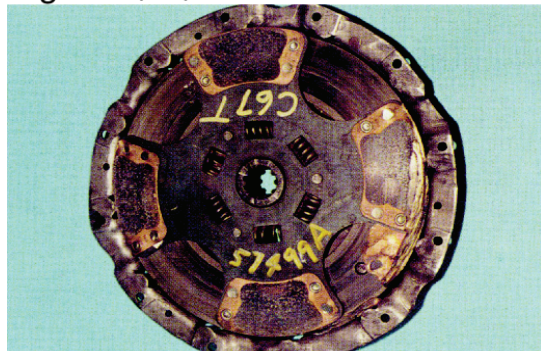
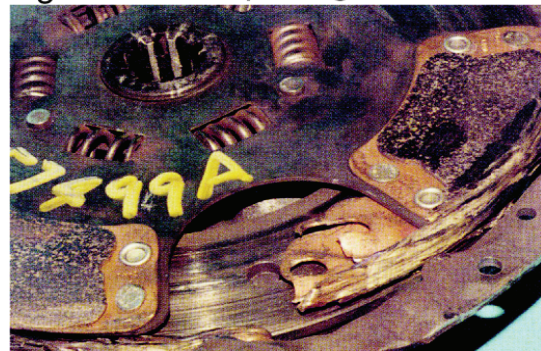
Example: Coasting a tractor down an unloading ramp can burst a driven disc. See Figures 67, 68, and 69.

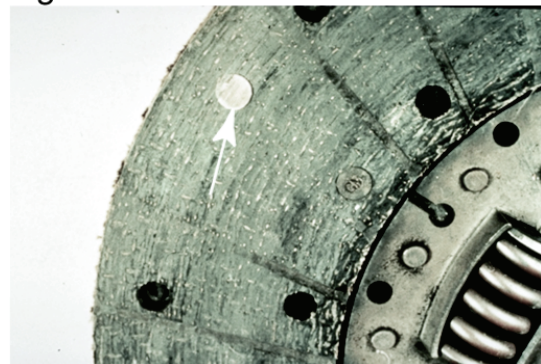
Fig 70

When the rivets (those which secure the facing material to the driven disc) begin to contact either the pressure plate, intermediate plate, or flywheel, then the entire clutch assembly is ready for replacement. Referring to the arrow in Figure 70, this rivet has been making contact with the pressure plate shown in Figure 17. Note the "shiny" appearance of the rivet and also the resulting "groove" on the pressure plate.

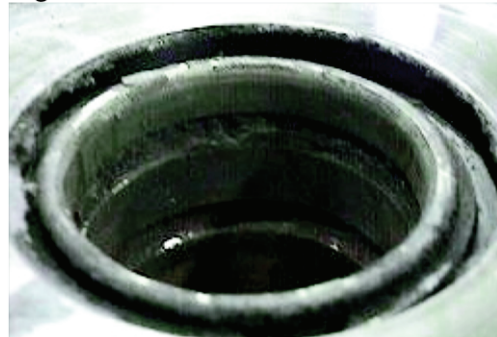
Fig 78

- A potential result of this wear is that the release yoke will force the bearing and sleeve assembly against the input shaft. Consequently, this “side loading” condition can damage the bushing, sleeve, and input shaft (see Figure 78).
